Manhole Inspection Summary

Manhole # S27I__030MH

Location Address: **914 HOLLINS ST**

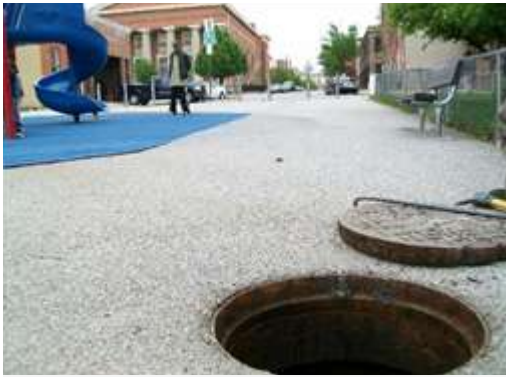
Location View

Comments **LOCATED AT JAMES MCHENRY ELEMENTARY SCHOOL PLAYGROUND; FORCED OPEN WITH 16LB MAUL AND SPRAY LUBRICANT**
